DINSMORE STORAGE No. 2 DAM

NDI No. PA 00497  
PennDER No. 63-20

PHASE I INSPECTION REPORT  
NATIONAL DAM INSPECTION PROGRAM

MICHAEL BAKER, JR., INC.

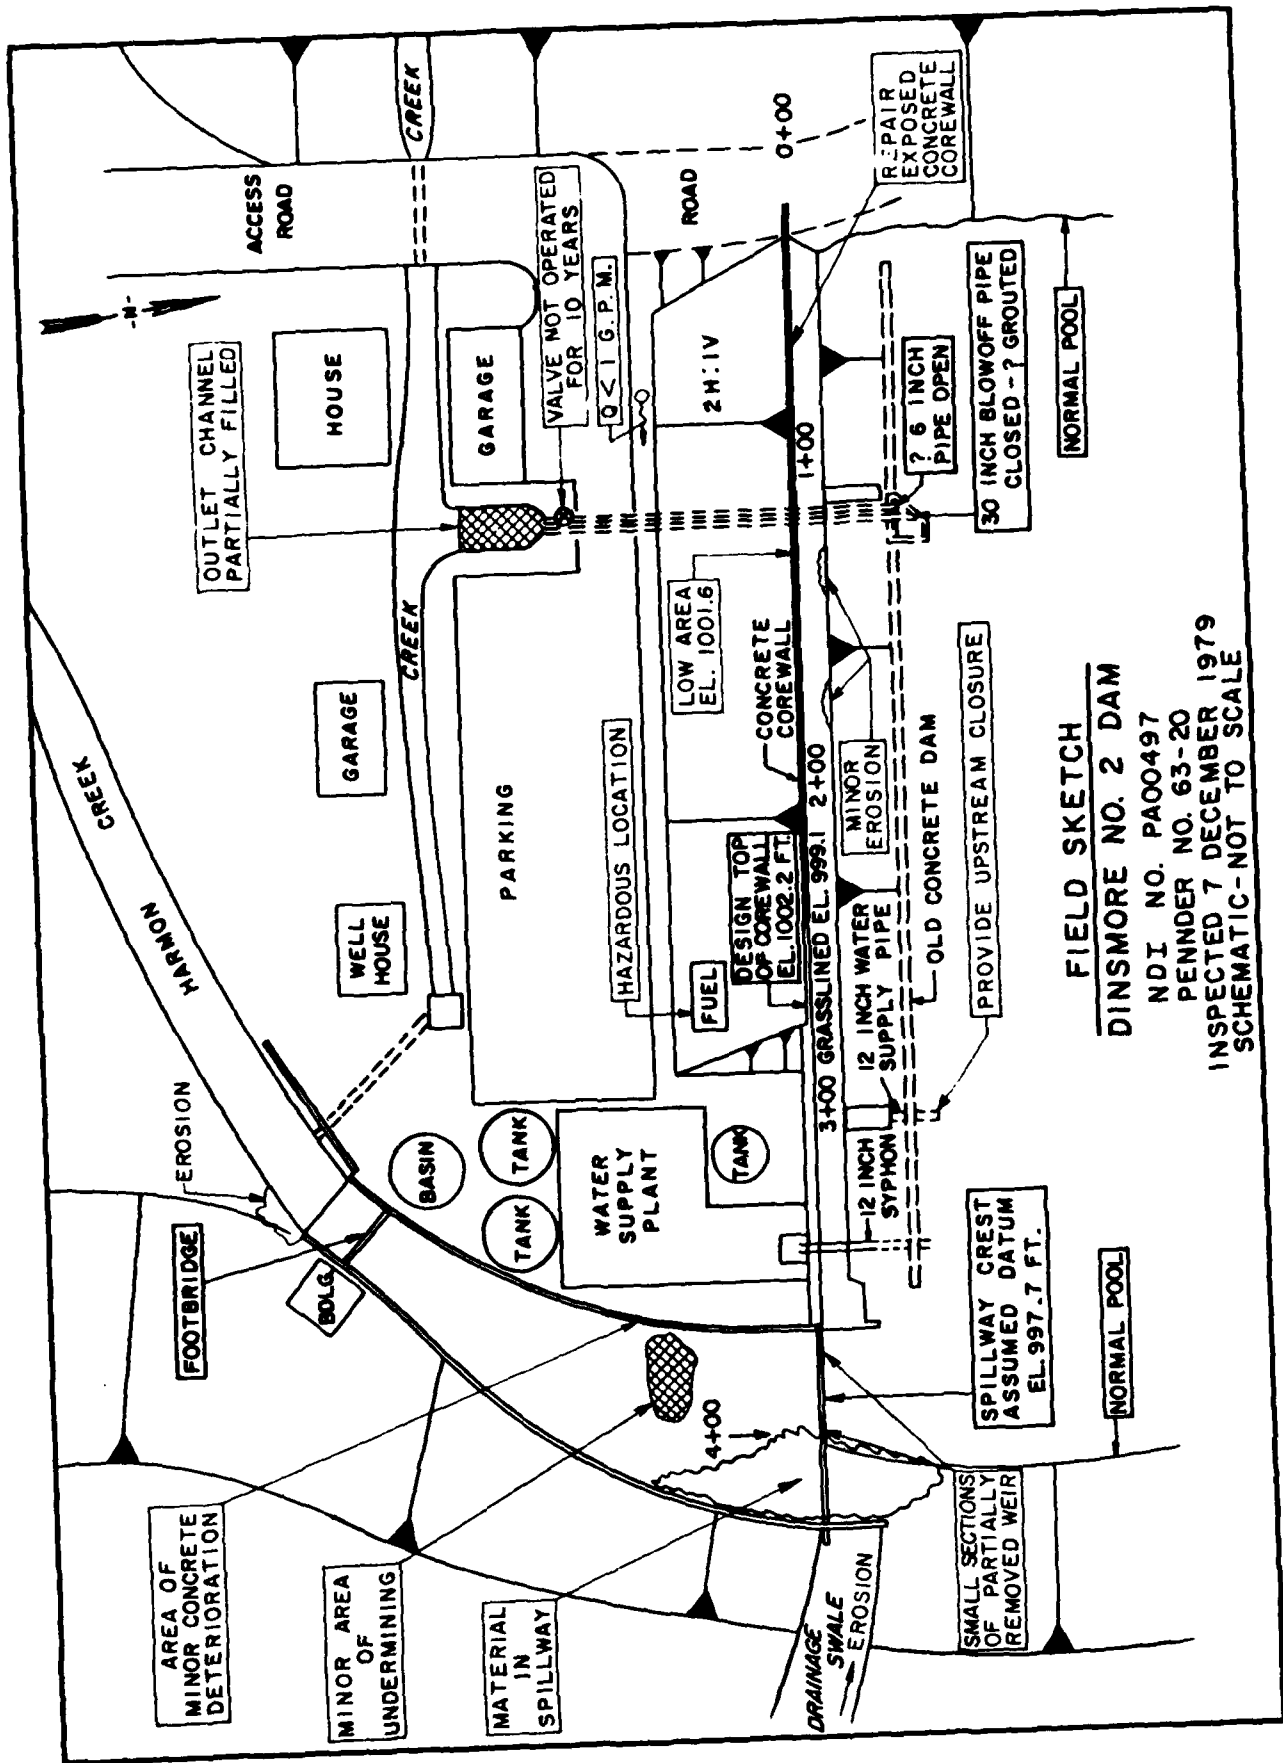
FIELD SKETCH  
 DINSMORE NO. 2 DAM  
 NDI NO. PA00497  
 PENNDR NO. 63-20  
 INSPECTED 7 DECEMBER 1979  
 SCHEMATIC-NOT TO SCALE

| VISUAL EXAMINATION OF | OBSERVATIONS | REMARKS OR RECOMMENDATIONS |
|---|--|---|
| ANY NOTICEABLE SEEPAGE | Minor seepages (Q < 1 g.p.m.) coming<br>from toe of embankment near the right<br>downstream end (see Field Sketch). | This area should be visually<br>examined in future inspections<br>and the condition recorded. |

Repairs were made to the left training wall on the downstream slope in 1960. These repairs consisted of placing concrete (gunite) along the base of the wall to keep water away from the training wall. Some minor undermining of the channel paving is occurring. (See Field Sketch for approximate location.) The right training wall of the spillway is cracked and deteriorated at the location shown on the Field Sketch.

Repair undermined area. Repair training wall where necessary.
